**BLACKSTONE RIVER BASIN  
WORCESTER, MASSACHUSETTS**

**COES RESERVOIR DAM  
MA 00120**

**PHASE I INSPECTION REPORT  
NATIONAL DAM INSPECTION PROGRAM**

**AUGUST, 1978**

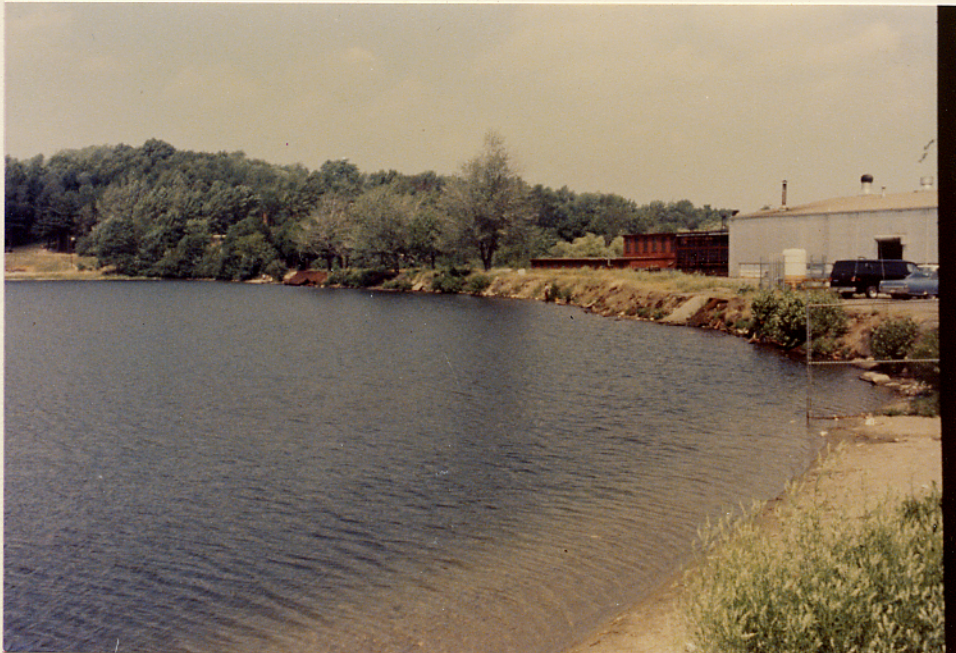
**VIEW FROM UPSTREAM OF SOUTH ABUTMENT**

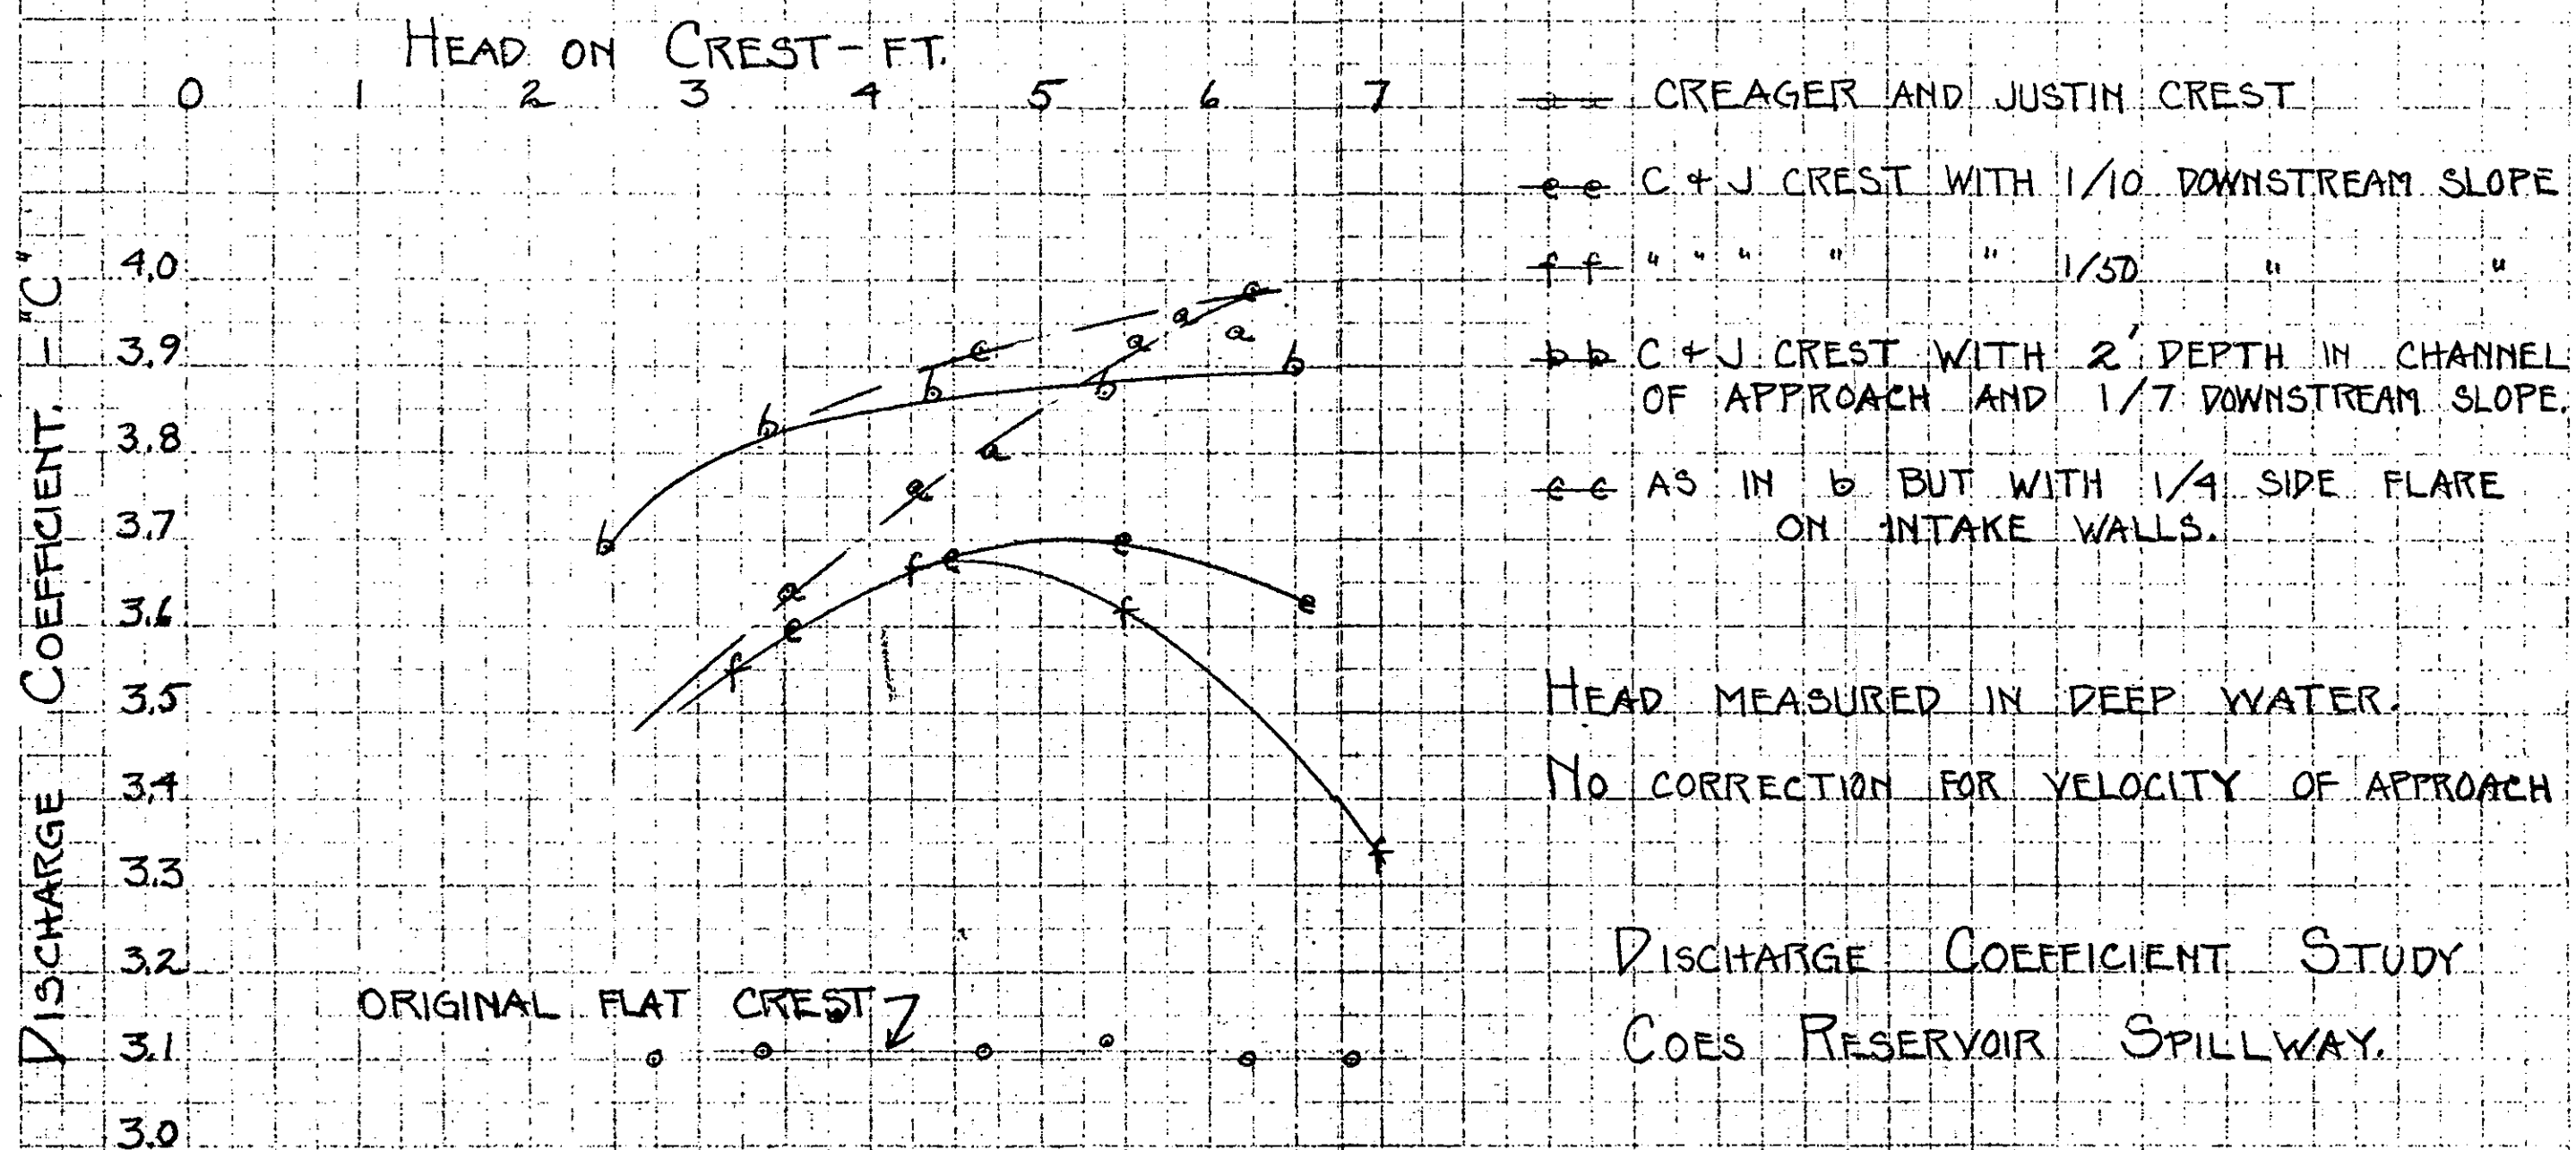
FIG 1

It will be noted that the coefficient of discharge for the original spillway section was found to be 3.11 at a design head of 5 feet. The coefficient of discharge for the recommended spillway ("c" points) was found to be 3.97 at the head of 6 feet. This is an increase in discharge capacity of 27% per foot of spillway length. The fact that this coefficient of discharge is very close to the normal Creager and Justin value indicates that very little further improvement is possible. The desirable hydraulic design indicated by these tests is given in Figure 2. Briefly the reason for some of these details is as follows:

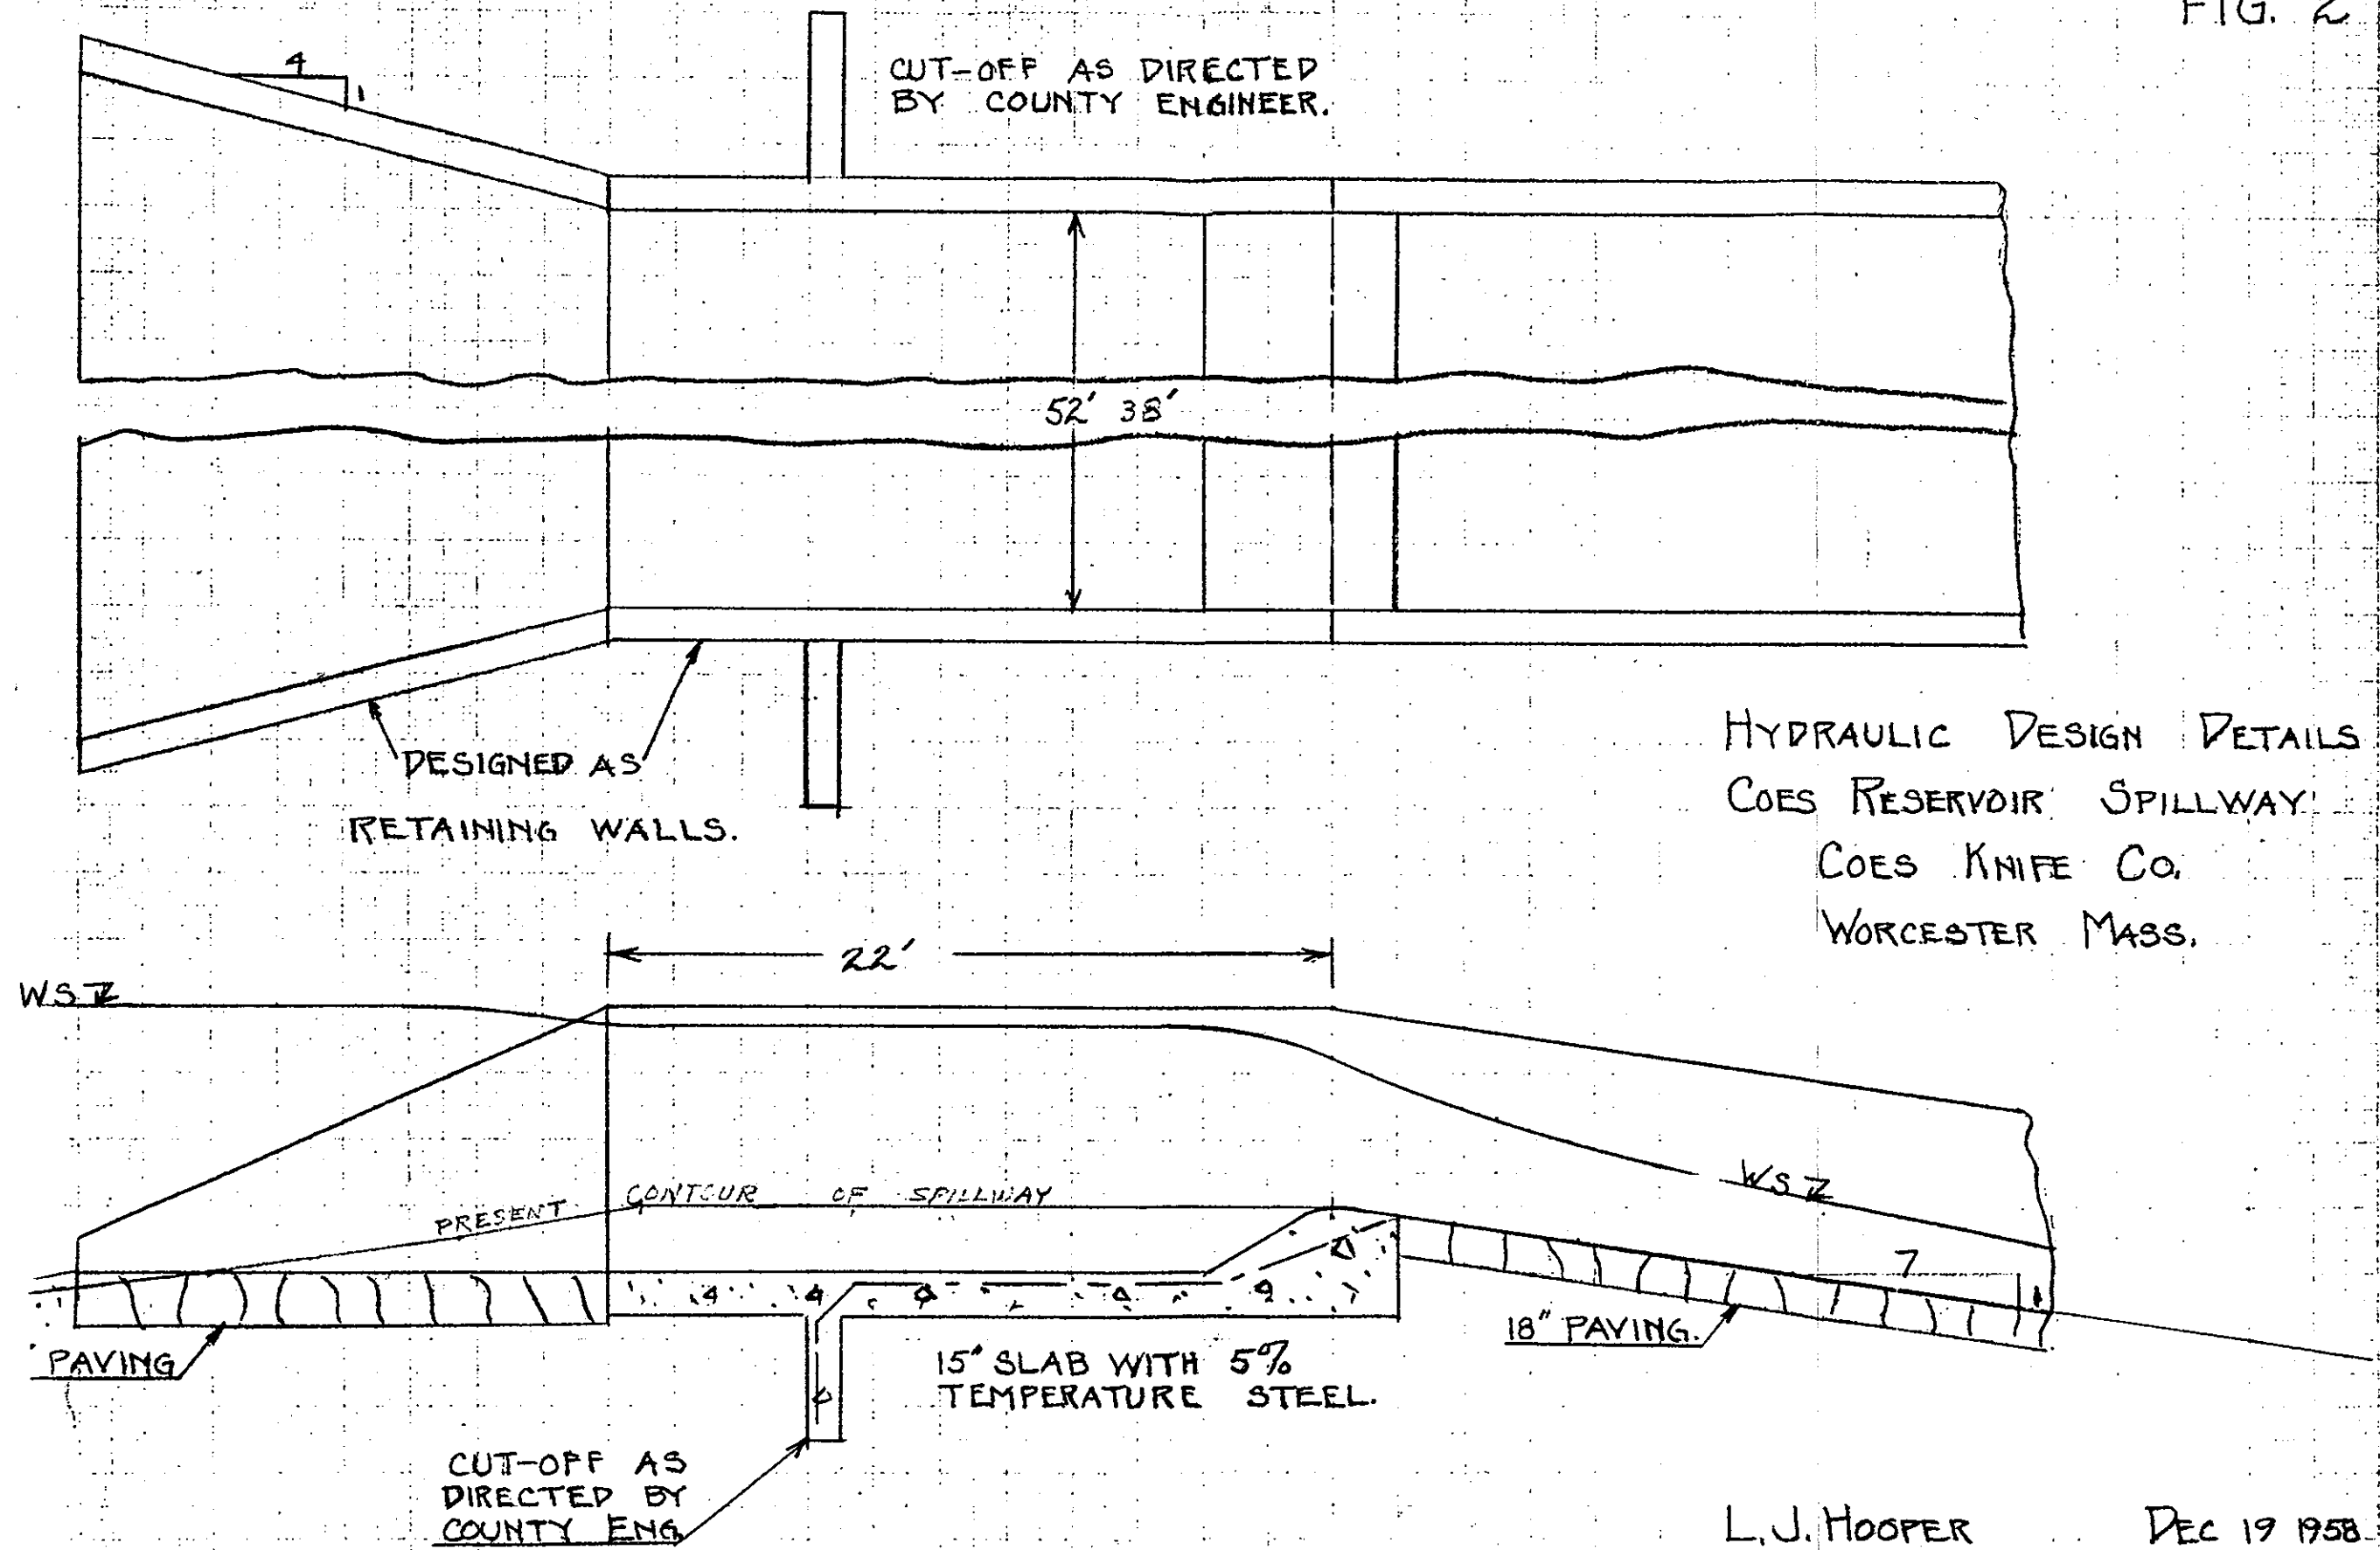
FIG. 2

The general arrangement for the hydraulic design is given in Figure 2, and the details of the spillway cross section shape are given in Figure 3.
